Case Study Provided by Advanced Home Energy

Client in Walnut Creek, CA

Audit Summary of findings (see pics next page)

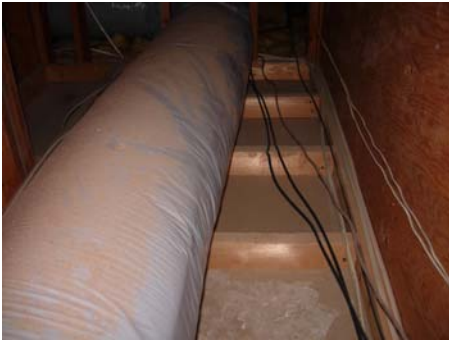
1. Missing Insulation on attic floor

- Fixed attic insulation
 - Fixed insulation that was currently in place to have it touch the thermal boundary
 - Installed Cellulose stabilized borate formula blown-in insulation to R-38

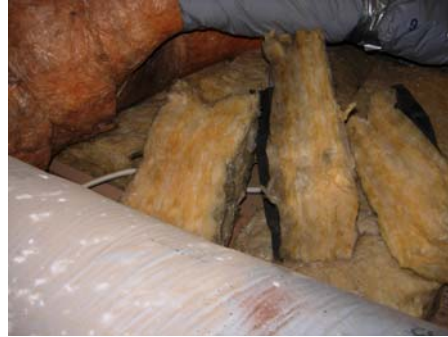
2. Poorly installed insulation on attic floor

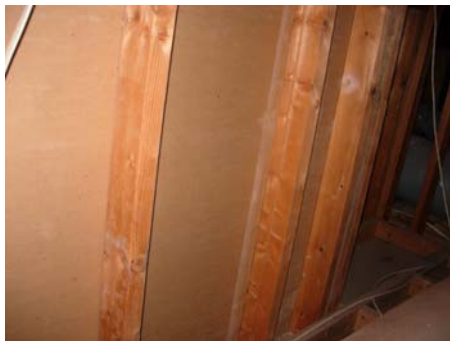
3. Uninsulated knee-walls

- Attic ruler every 300 sq. feet
 - Insulated attic walls with encapsulated fiberglass
 - Telescoped hose over vaulted ceilings and blow insulation in these cavities. NOTE: because we could not see this area above the ceiling we could not assure complete coverage in these areas.

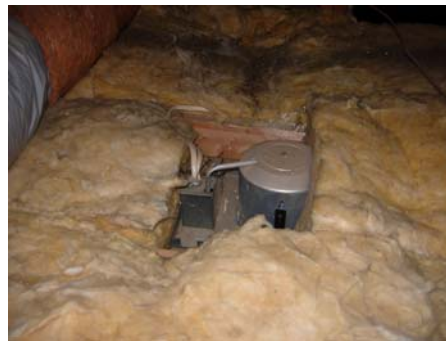
4. Fiberglass touching recessed light

- Sealed all penetrations from attic to conditioned space to prevent excessive drafts. Sealed around recessed lights, around duct supply plenum, boot penetrations, electric and plumbing penetrations.

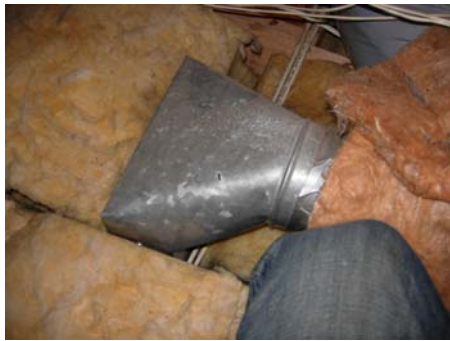
5. Leaky boots (using duct tape)

- Cleaning of Duct System – Opened up 11 x registers and scrape out inside of boot, vacuum inside of boots and close.
- Pressurized duct system with Duct Blower, sealed system using mastic and metal tape to reduce leakage. Results: reduced leakage from 230 CFM to 127 CFM

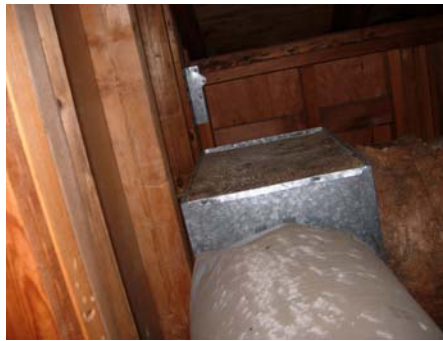
6. Uninsulated a leaky return plenum

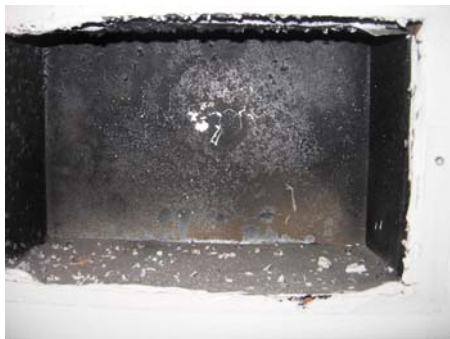
7. Looking inside very dirty duct register

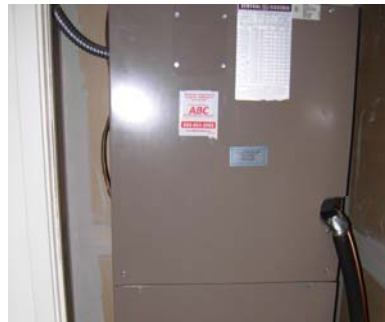
8. Electric furnace for primary heating
